Ultrasound-assisted Rare Case of Misplaced Hemodialysis Catheter

Journal of Medical Academics (2019); 10.5005/jp-journals-10070-0039

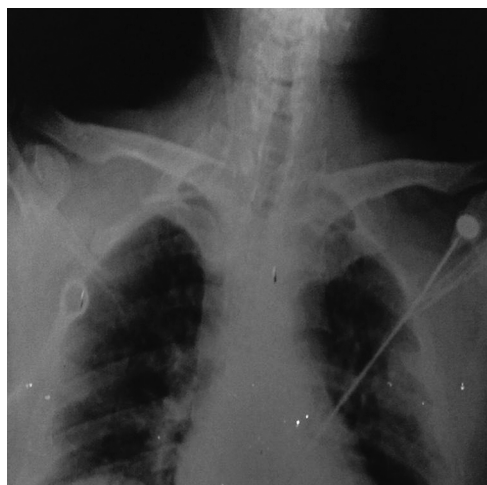
Fig. 1: Chest X-ray showing hemodialysis catheter in right subclavian vein

A 58-year-old male, a known case of ESKD, presented to the dialysis center for his routine hemodialysis. The patient had undergone creation of arteriovenous fistula recently and was dependent on temporary non-cuffed double-lumen catheter for vascular access. The patient had undergone multiple cannulations of the RIJV and subclavian vein in the past, and a history of infection of the catheter placed in the right subclavian vein had also been documented. Nevertheless, the patient was planned for a double-lumen right jugular vein hemodialysis catheter insertion in the intensive care unit for the dialysis. With aseptic precautions, under real-time USG, a 12-F double-lumen hemodialysis catheter was inserted using the modified Seldinger technique. Prior to dilatation of the tract, the guide wire placement inside RIJV was confirmed with USG by the appearance of a bright dot inside the RIJV. Slight difficulty was encountered in passing the guide wire at 10 cm, but it was further advanced by gentle manipulation. No arrhythmias were noticed on insertion of the guide wire, but USG showed the guide wire tip inside the lumen of internal jugular vein. The tract was dilated, and the dialysis catheter was introduced uneventfully. However, when a postprocedure chest X-ray was taken to confirm the position of the catheter, it was found that the catheter tip had migrated into the right subclavian vein (Fig. 1).

congenital or acquired anatomical anomalies.³ The index patient had multiple cannulations of the right jugular and subclavian vein in the past, as well as a history of infection of the catheter placed in the right subclavian vein. The misplacement in the present case reported may be due to misplacement of the guide wire into the right subclavian vein due to stenosis of the superior vena cava. Even though entry of the catheter into a planned vein can be ensured using USG transducer stabilization device, its subsequent passage cannot be controlled.⁴ To conclude, real-time USG increases the success rate of CVC placements, but postprocedure radiography is of paramount importance to confirm ideal catheter positioning prior to starting hemodialysis,
